PROTECT68 PRESSURE CONTROL KIT

1030362 2007-2018 68RFE Transmission

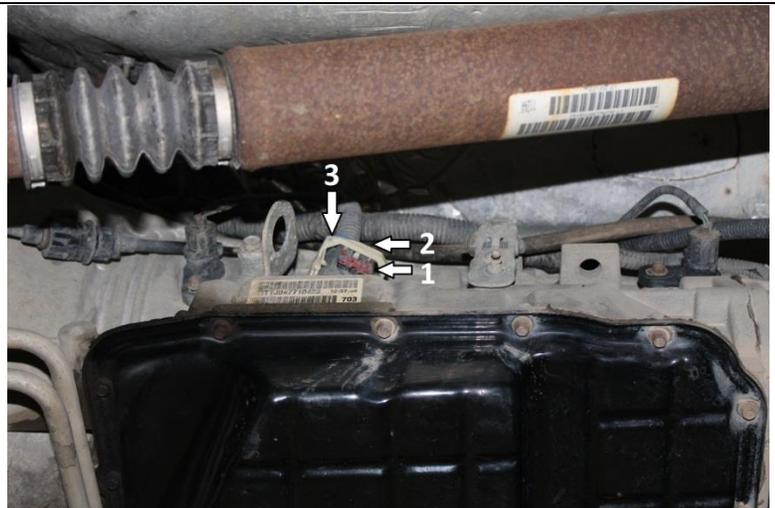
6. To remove connector, push red tab (1) downwards. Then, press the black tab (2) which will allow the white handle (3) to be rotated downwards, releasing the connector from the transmission.

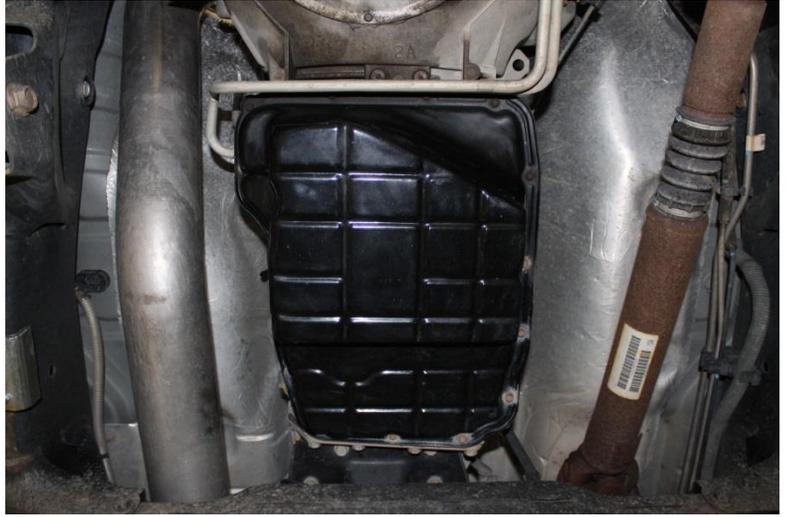
8. Remove 14 of the 15 transmission pan bolts (8mm). Loosen the remaining bolt but leave in place to keep the pan from falling. The transmission cooler lines may need to be moved to access some of the bolts, gently pry them out of the way.

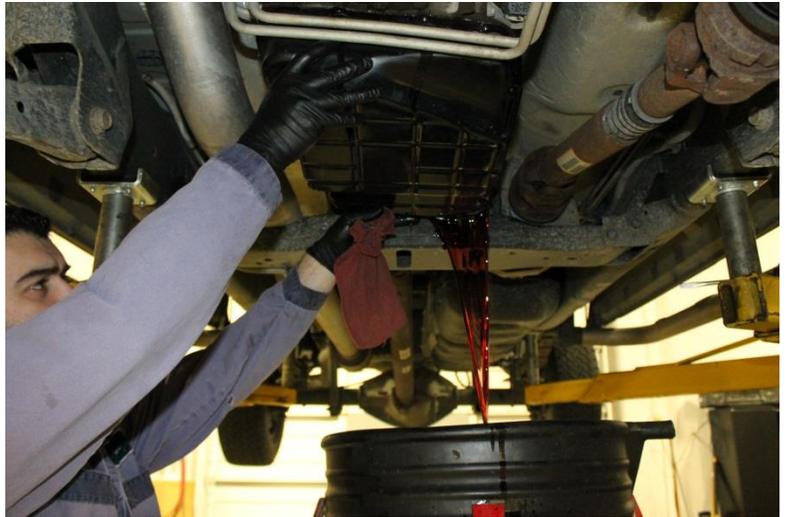
9. Tap pan with a mallet to break the silicone gasket seal. Allow fluid to drain. Remove last screw and drain remainder of fluid.

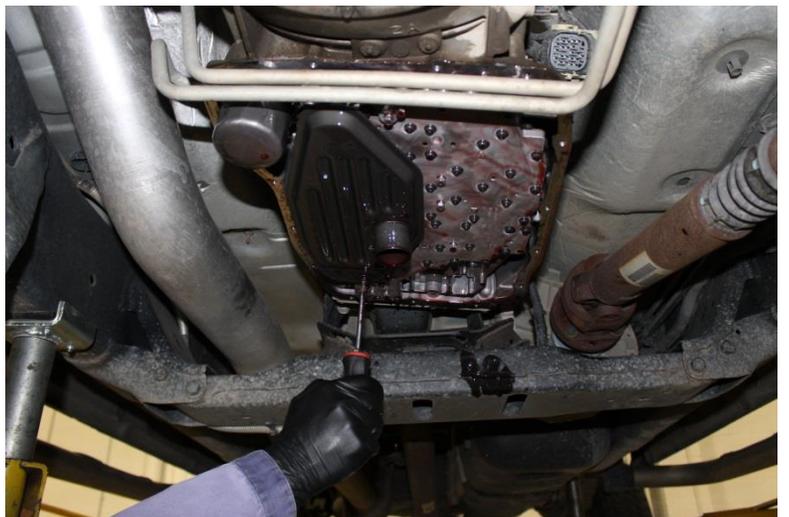
10. Remove transmission filter by removing the one T25 Torx screw.

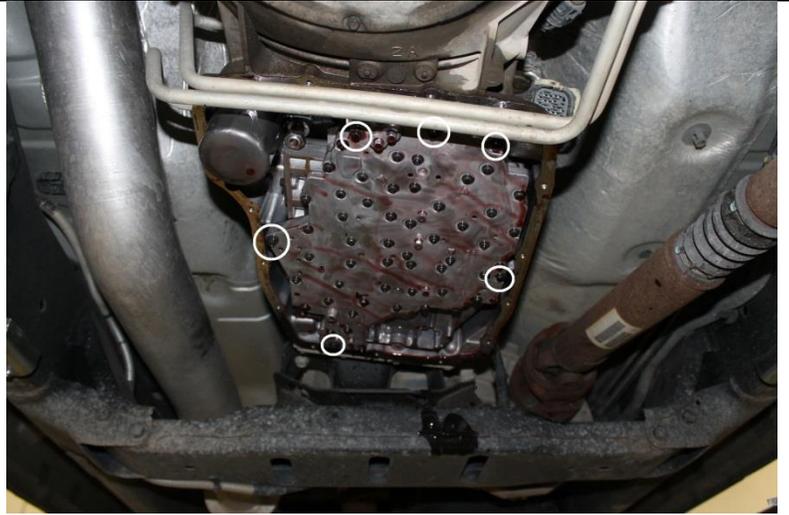
11. Remove the six 8mm bolts securing the valve body to the transmission. Drain valve body of fluid. To remove valve body from transmission, wiggle it while pulling downwards to work the electrical connector through the case.

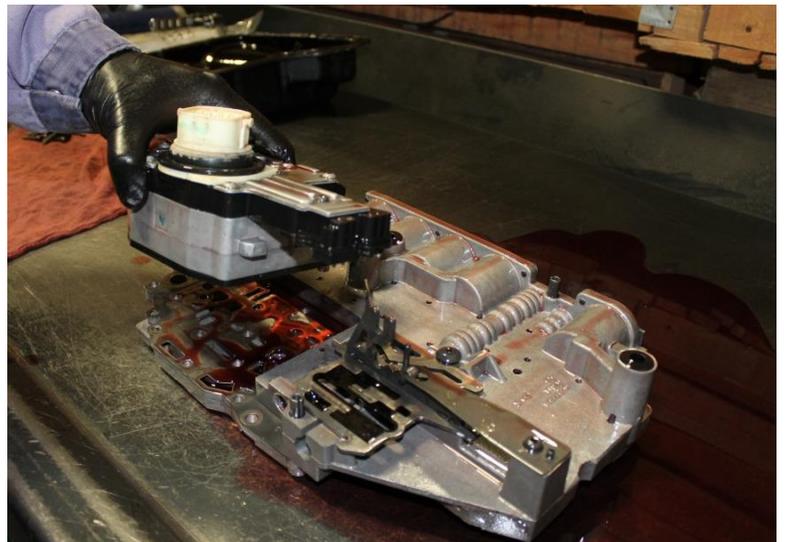
13. Remove fifteen T25 Torx screws securing the solenoid pack to the valve body, remove solenoid pack and place it to the side.

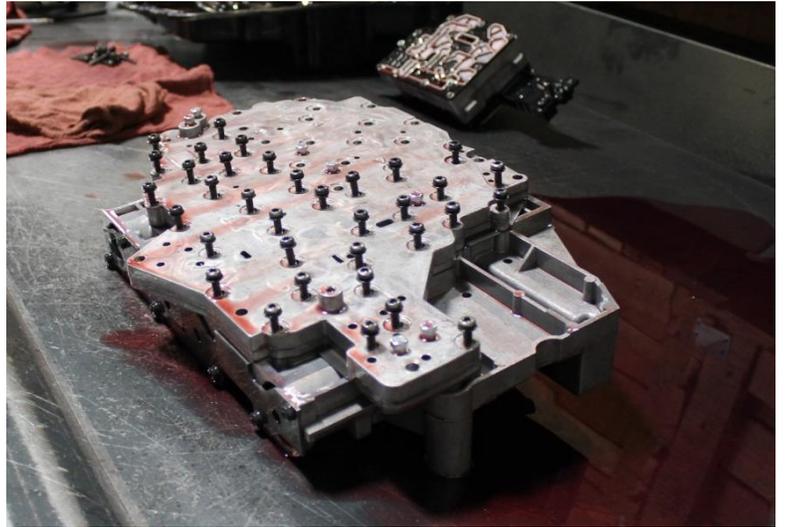
14. Remove remaining thirty-five T25 Torx screws securing the valve body halves.

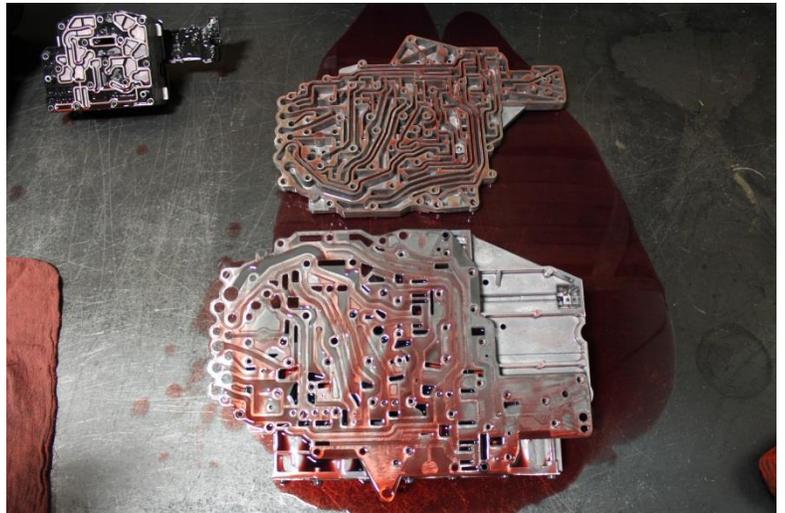
15. Carefully separate the two halves of the valve body. Separate as shown in pictures – *do not invert the larger (top) portion as it contains plastic check balls*. The two halves will have to be wiggled apart as the alignment dowels will be holding them together.

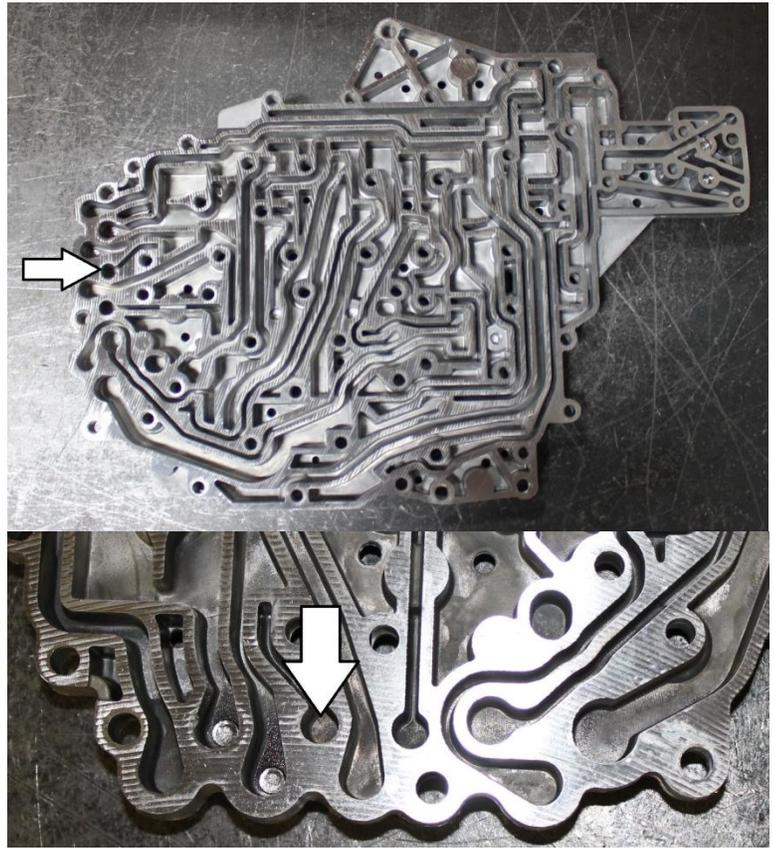
17. Thoroughly clean the bottom (smaller) half of the valve body. Locate the passage to be drilled.

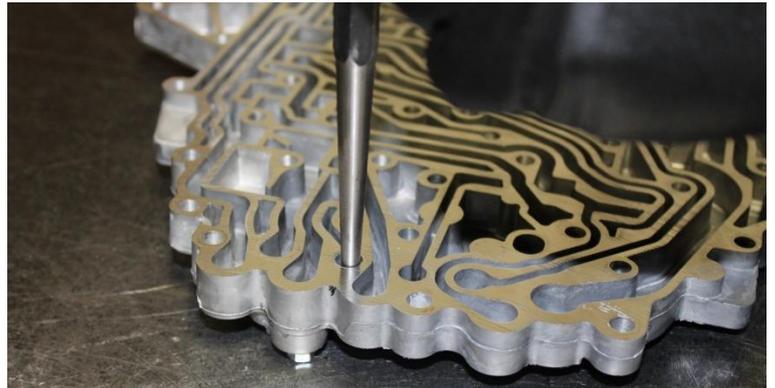
18. Punch center of hole using a center punch.

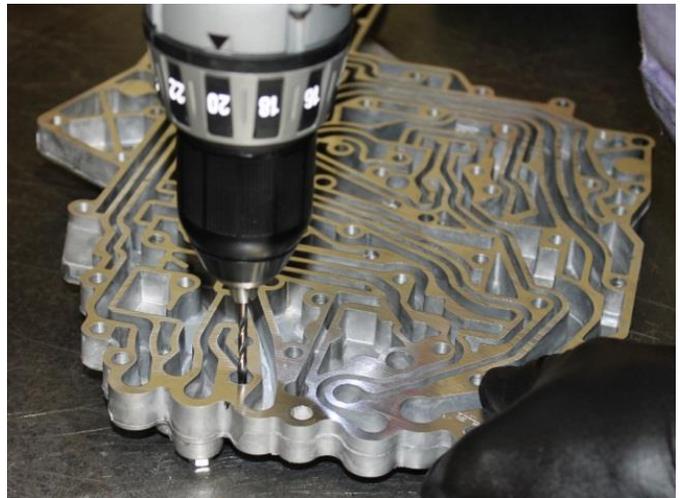
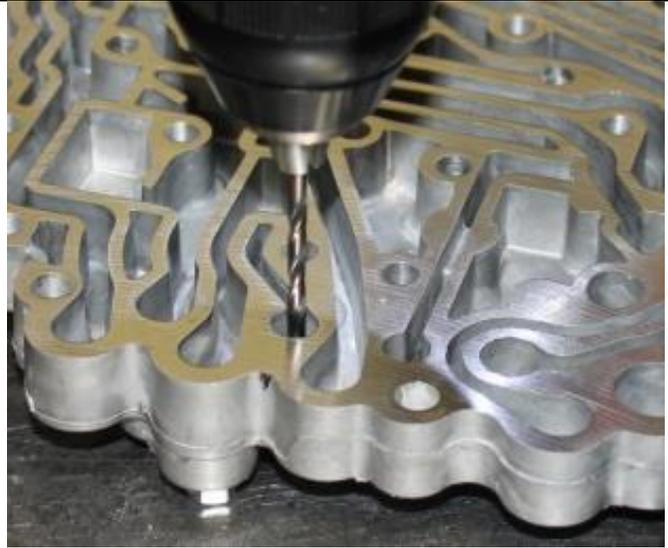
19. Drill hole with 1/8" drill bit.

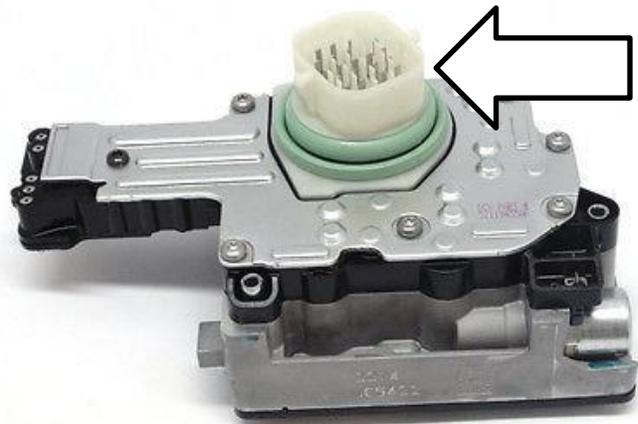
21. **IMPORTANT!** Ensure that all the check balls are in the locations shown.

If the electrical connector on the valve body is white make sure you have all seven check balls installed.

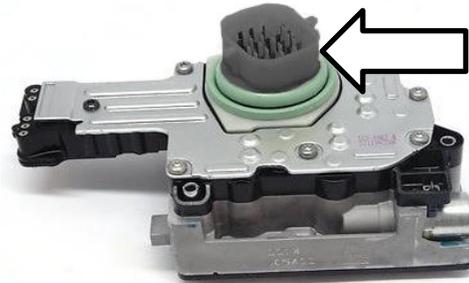
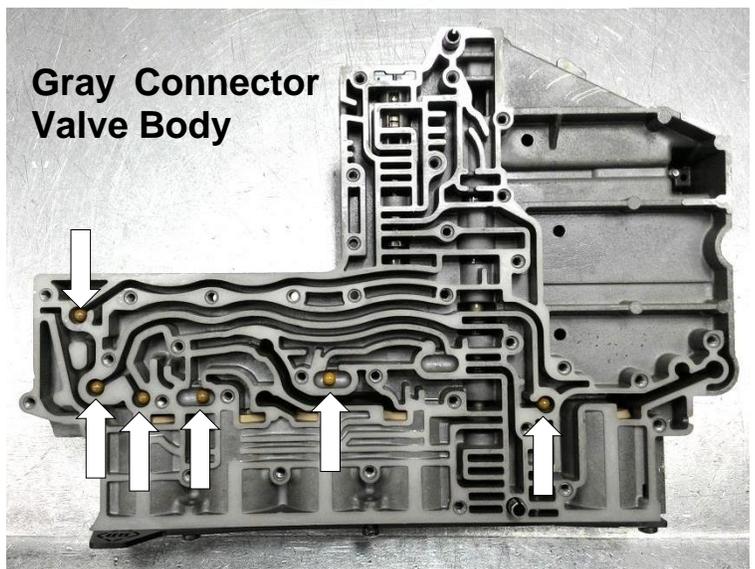
22. IMPORTANT! Ensure that all the check balls are in the locations shown.

If the electrical connector on the valve body is gray you will install six check balls rather than the five that were originally installed.

Use the supplied extra check ball included in this kit for this. Refer to the diagram on the right.

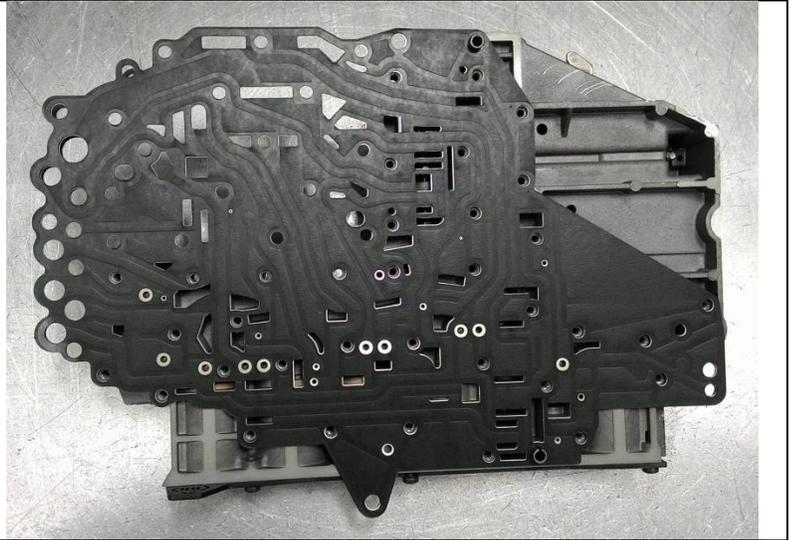
23. Install the BD bonded gasketed separator valve-body plate (1600188).

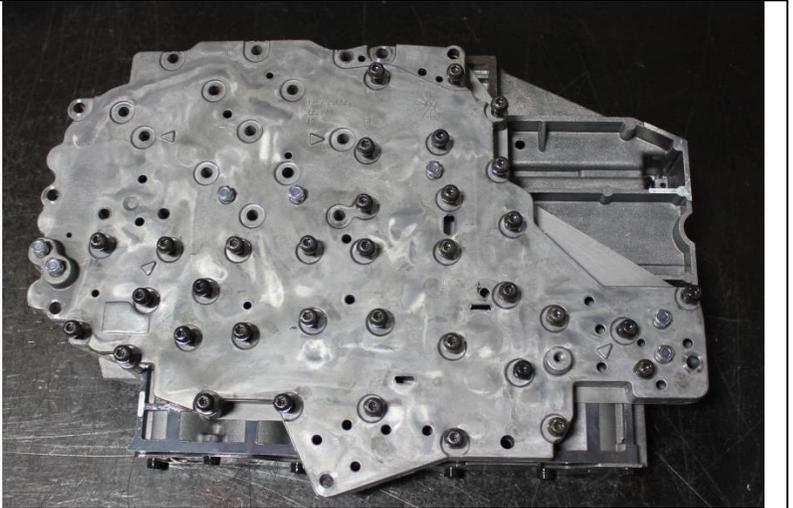
24. Re-install bottom (smaller) half of valve body. Ensure it fits flat on the separator plate/gasket. It may need to be worked downwards while rocking to be installed over the dowels. Install attaching screws so they are fully seated but do not tighten until the solenoid pack has been installed.

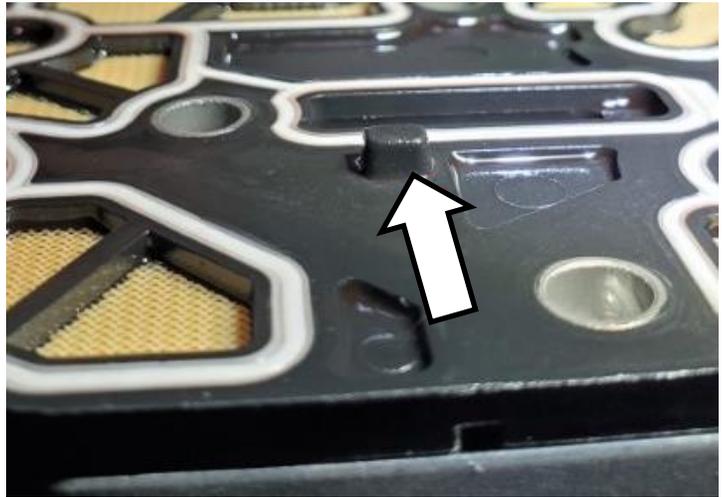
IMPORTANT! – On rare occasions, the solenoid pack gasket comes with a small nub on one side which will need to be removed using a file or blade before installation as the new plate blocks off the opening as it is not present on most applications.

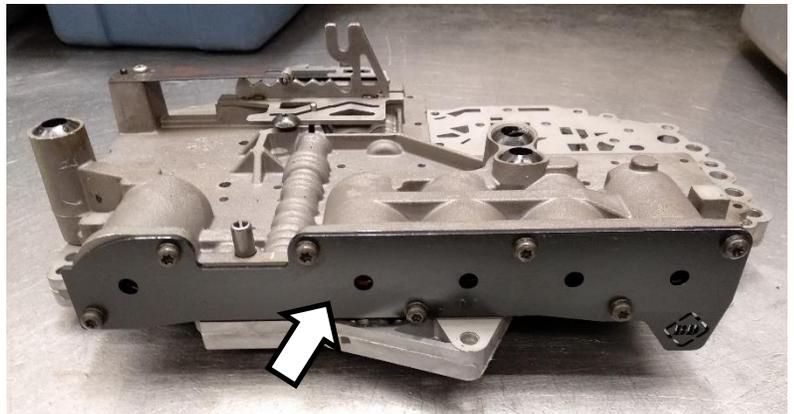
27. Remove the accumulator retainer plate and reinstall the supplied BD accumulator plate. **Torque screws to 50 in-lb.**

IMPORTANT: Over or under-torquing these fasteners can lead to blown out accumulator plates.

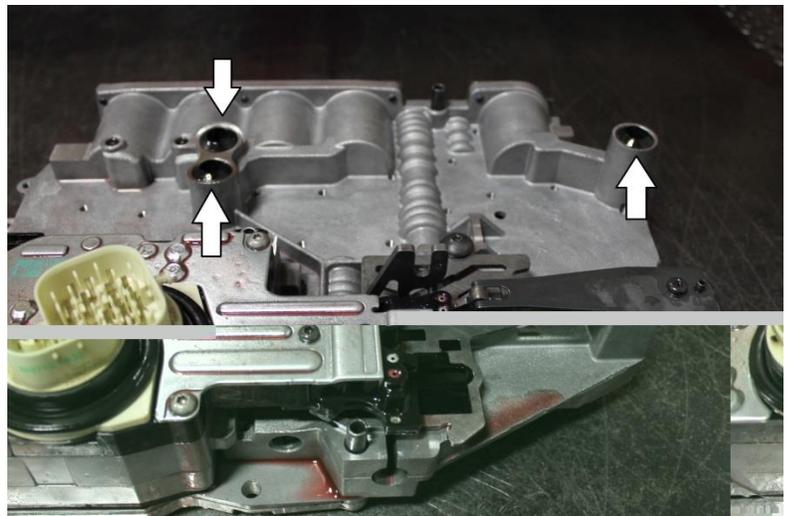
28. Inspect the three rubber seals on the top of the valve body, replace with supplied seals if they are nicked or otherwise damaged. Ensure the seal mating surface on the transmission is clean.

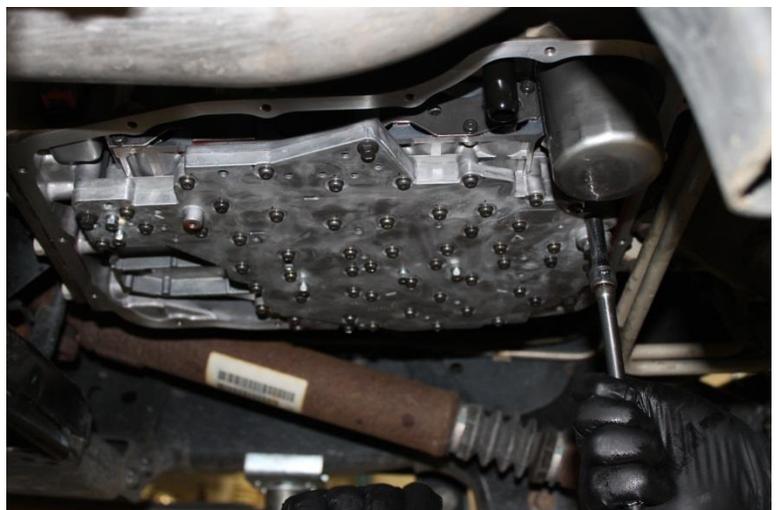
31. Torque the valve body attaching bolts to 105 in/lbs.

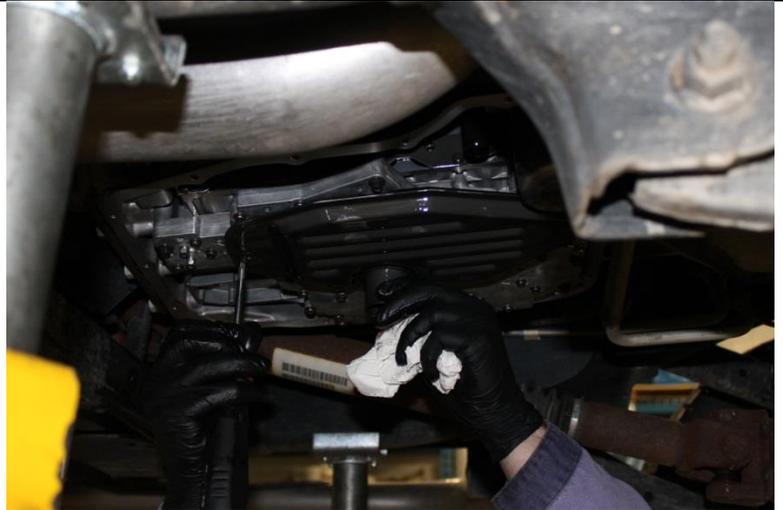
32. If desired, install new filter(s). Otherwise, reinstall the filter/pickup assembly. Torque to 50 in/lbs.

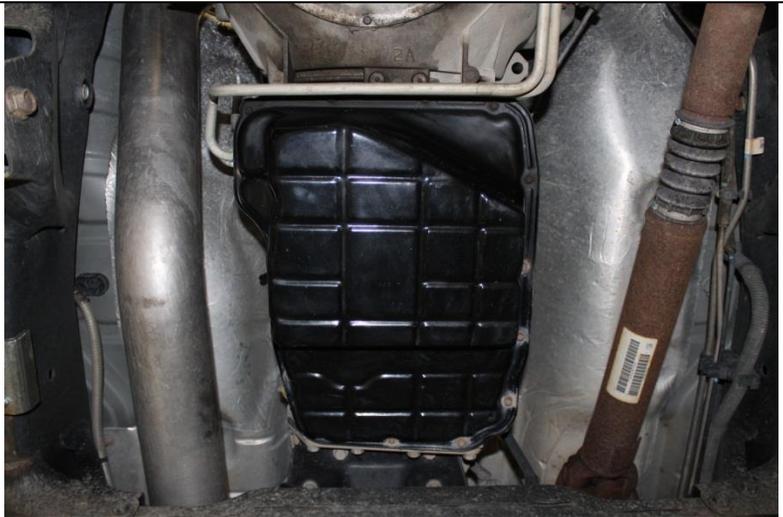
33. Place the supplied gasket on the transmission pan. Hold pan below transmission and install attaching screws. Torque the pan screws to 105 in/lbs.

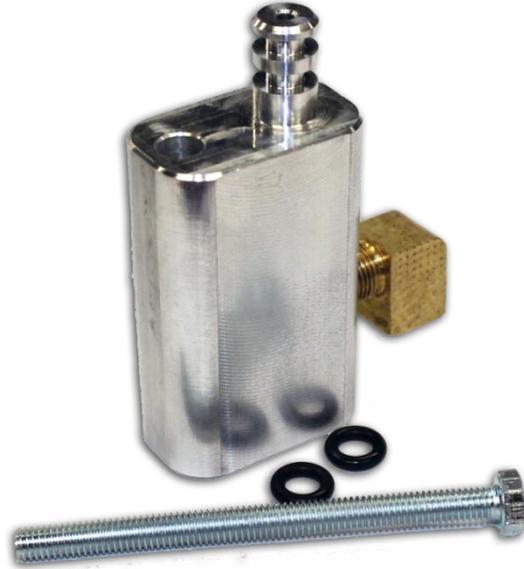
ADAPTER KIT BD# 1061529

Use this kit with a 300 psi gauge.

41. Note. If you would like to verify the increases in line pressure, use adapter kit (BD 1061529) in conjunction with a 300psi gauge. Pressures at wide open throttle should be between 240 – 260 PSI with a mechanical gauge.
