# 68 RFE PROTECT 68 PLATE KIT

### Part #: 1030373

2007-2018

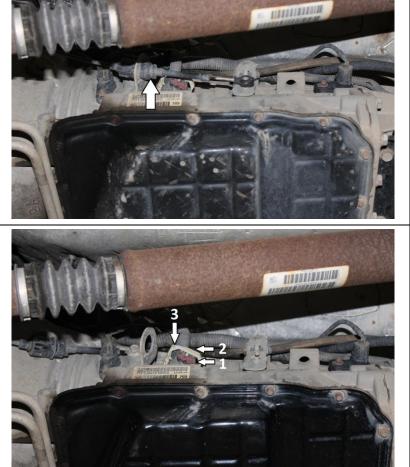
6. To remove connector, push red tab (1) downwards. Then, press the black tab (2) which will allow the white handle (3) to be rotated downwards, releasing the connector from the transmission.

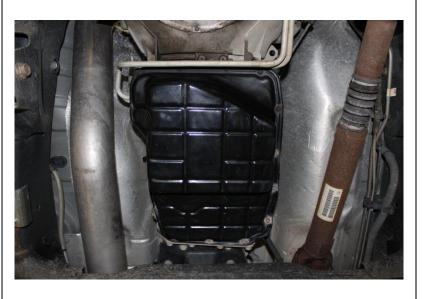
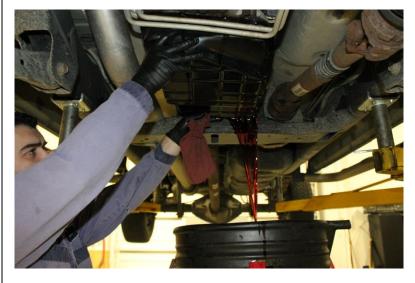
8. Remove 14 of the 15 transmission pan bolts (8mm). Loosen the remaining bolt but leave in place to keep the pan from falling. The transmission cooler lines may need to be moved to access some of the bolts, gently pry them out of the way.

9. Tap pan with a mallet to break the silicone gasket seal. Allow fluid to drain. Remove last screw and drain remainder of fluid. 10. Remove transmission filter by removing the one T25 Torx screw.

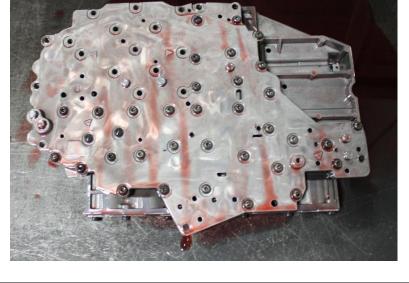
11. Remove the six 8mm bolts securing the valve body to the transmission. Drain valve body of fluid. To remove valve body from transmission, wiggle it while pulling downwards to work the electrical connector through the case.

12. Place the valve body on a

clean work surface.

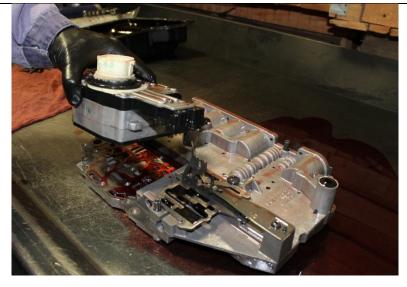
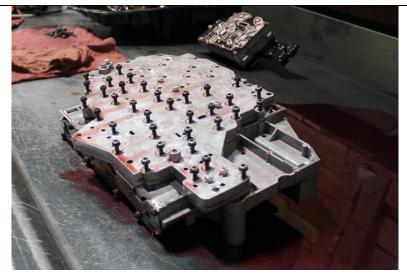
13. Remove fifteen T25 Torx screws securing the solenoid pack to the valve body, remove solenoid pack and place it to the side.

14. Remove remaining thirty five T25 Torx screws securing the valve body halves.

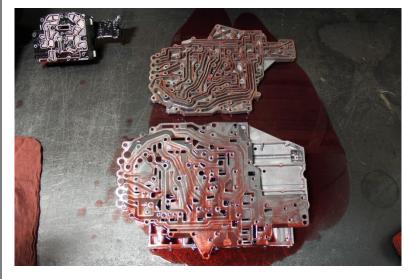
15. Carefully separate the two halves of the valve body. Separate as shown in pictures – do not invert the larger (top) portion as it contains plastic check balls. The two halves will have to be wiggled apart as the alignment dowels will be holding them together.

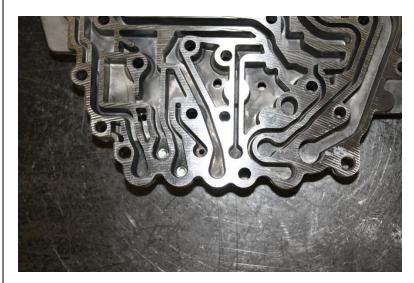
21. **IMPORTANT!** Ensure that all the check balls are in the locations shown.

If the electrical connector on the valve body is <u>white</u> make sure you have all <u>seven</u> check balls installed.

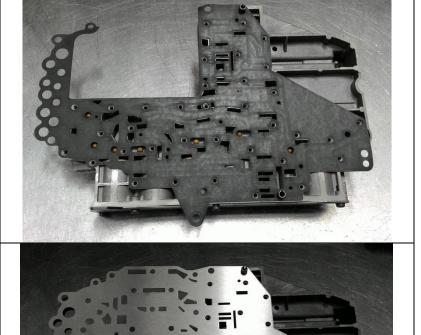
24. Install BD separator plate. Ensure it fits flat on the valve body.

25. Install the second BD valve body gasket part number 1600186-2 on the separator plate, lining it up with the dowels.

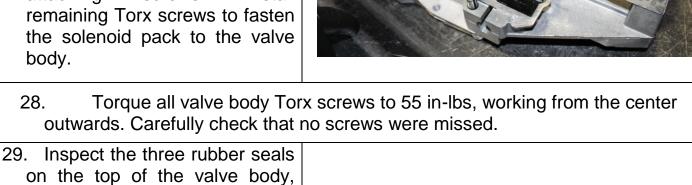
28.

- 26. Re-install bottom (smaller) half of valve body. Ensure it fits flat on the separator plate/gasket. It may need to be downwards worked while rocking to be installed over the dowels. Install attaching screws so they are fully seated but do not tighten until the solenoid pack has been installed.
- 27. Re-install solenoid pack onto valve body. Be sure to properly align the pin on the solenoid pack with the slot on the valve body. Due to the alignment dowels, the valve body may need to be wiggled down into position. Install solenoid pack attaching Install screws. remaining Torx screws to fasten the solenoid pack to the valve body.

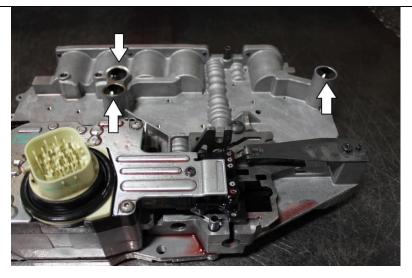
replace with supplied seals if they are nicked or otherwise damaged. Ensure the seal mating surface on the transmission is clean.

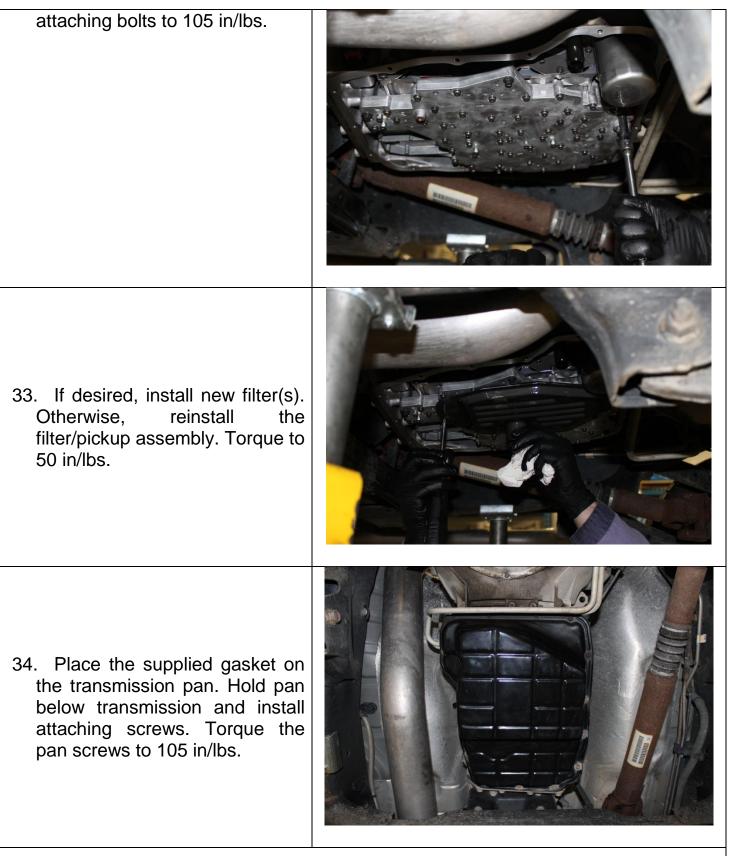
35. Apply dielectric grease (supplied in pressure enhancer kit) to main electrical connector and reattach connector. Reattach shifter cable to shift lever.

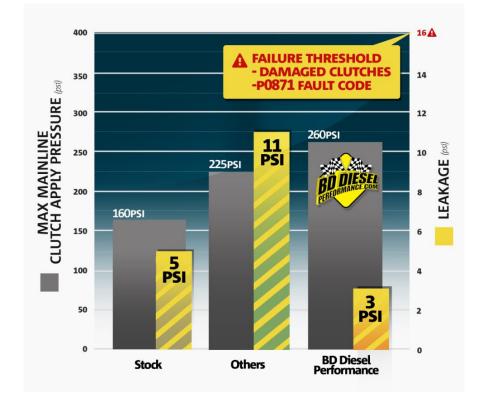
ADAPTER KIT BD# 1061529

Use this kit with a 300 psi gauge.

42. With this kit installed you will now have the capability to run 250psi of mainline pressure. Please ensure your transmission tuner knows that you have the BD Protect68 plate with gaskets installed.
