## **PROTECT68 PRESSURE CONTROL KIT**

**1030362 2007-2019 68RFE Transmission**

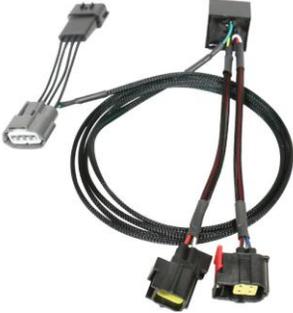
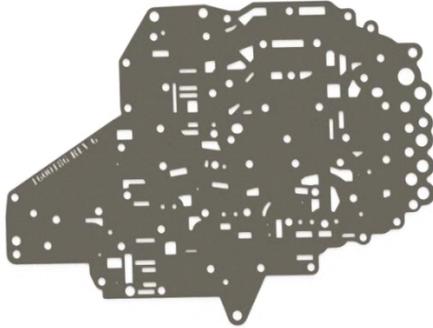
<b>68 RFE Pressure Controller</b>	<b>Clutch Feed Seal</b>	<b>Valve Body Plate</b>	<b>Gasket</b>
<b>Qty : 1</b>	<b>Qty : 3</b>	<b>Qty : 1</b>	<b>Qty : 1</b>

1600186-1	1600186-2	52118261	1600205

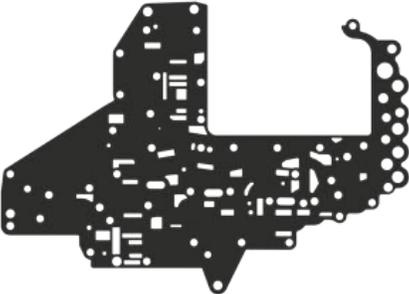
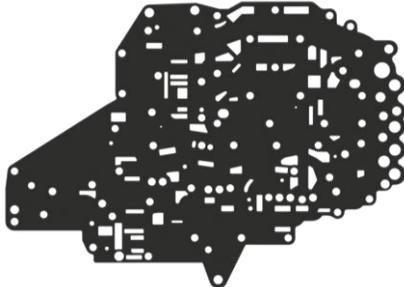
<b>Gasket</b>	<b>Gasket</b>	<b>Check Ball</b>	<b>Accumulator Plate</b>
<b>Qty : 1</b>	<b>Qty : 1</b>	<b>Qty : 2</b>	<b>Qty: 1</b>

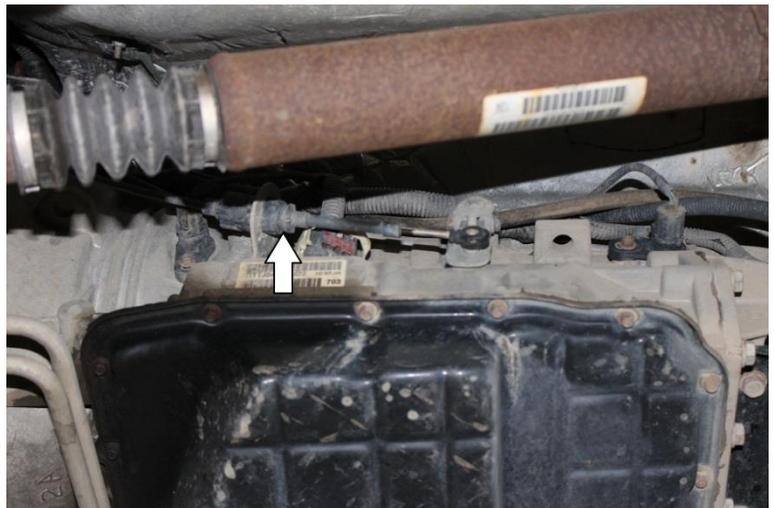
5. Remove shifter cable from transmission for better access to the main electrical connector.

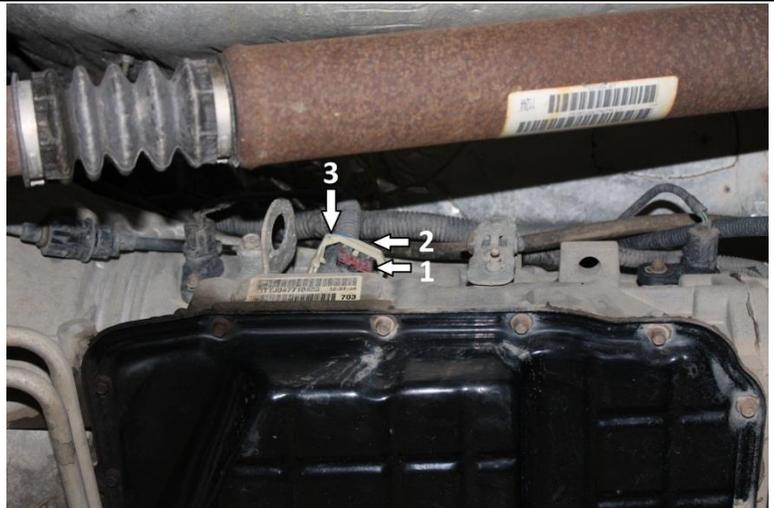
6. To remove connector, push red tab (1) downwards. Then, press the black tab (2) which will allow the white handle (3) to be rotated downwards, releasing the connector from the transmission.

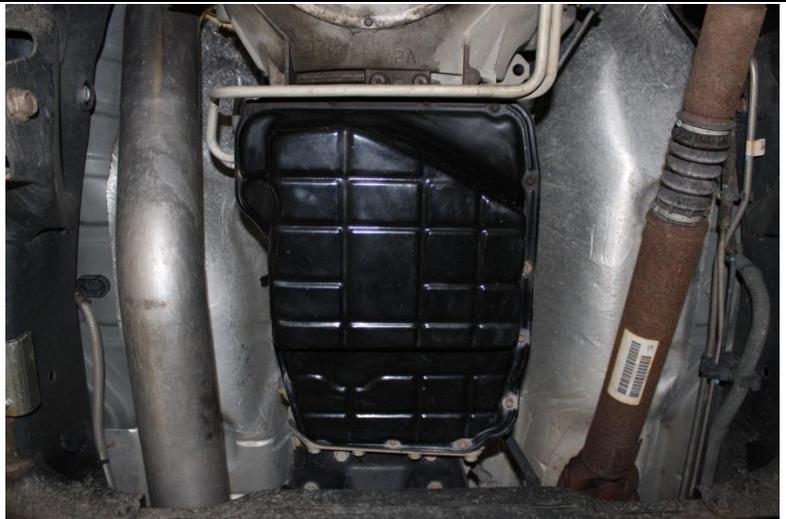
8. Remove 14 of the 15 transmission pan bolts (8mm). Loosen the remaining bolt but leave in place to keep the pan from falling. The transmission cooler lines may need to be moved to access some of the bolts, gently pry them out of the way.

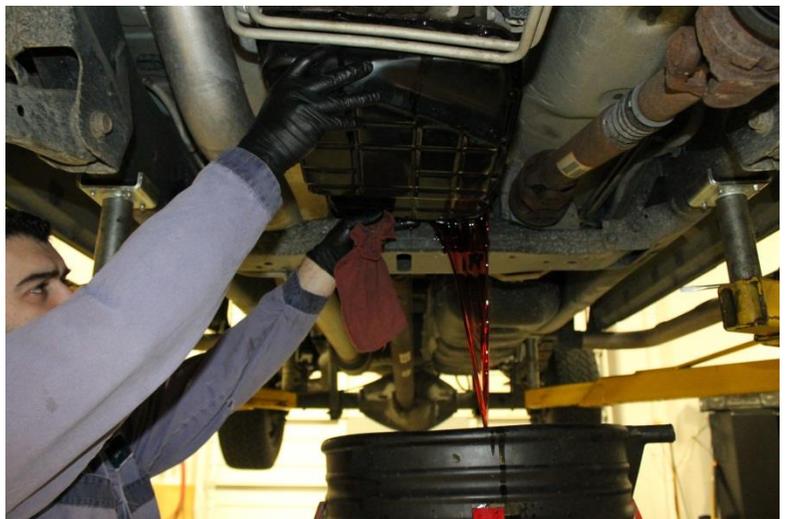
9. Tap pan with a mallet to break the silicone gasket seal. Allow fluid to drain. Remove last screw and drain remainder of fluid.

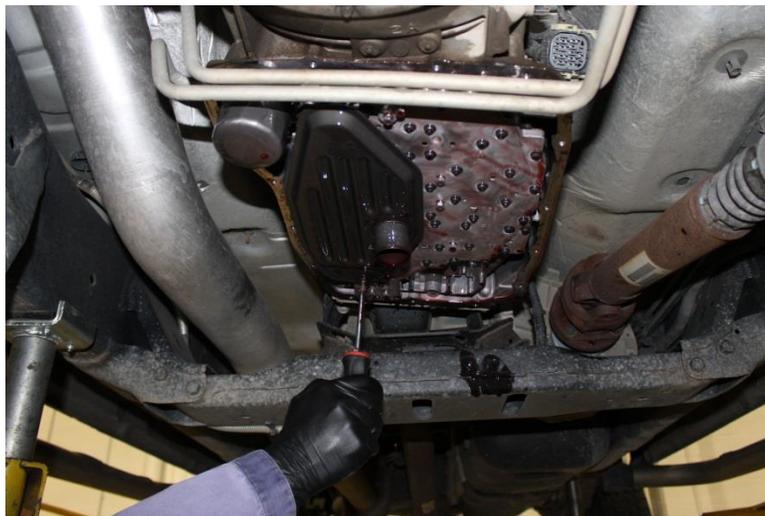
10. Remove transmission filter by removing the one T25 Torx screw.

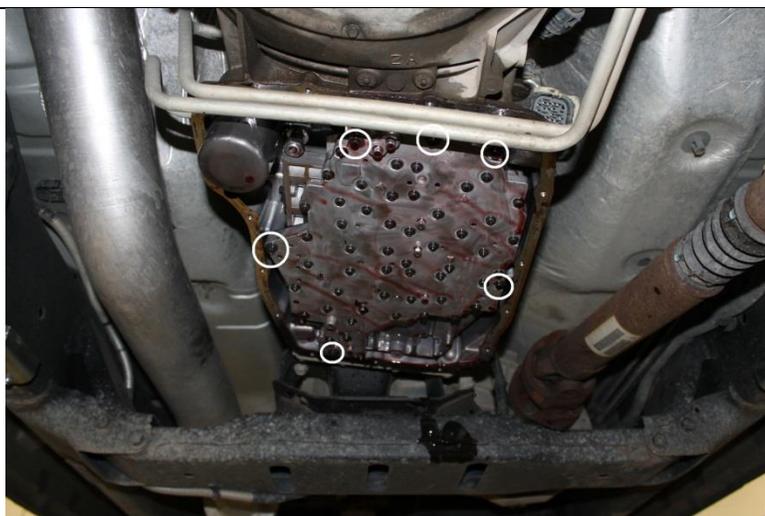
11. Remove the six 8mm bolts securing the valve body to the transmission. Drain valve body of fluid. To remove valve body from transmission, wiggle it while pulling downwards to work the electrical connector through the case.

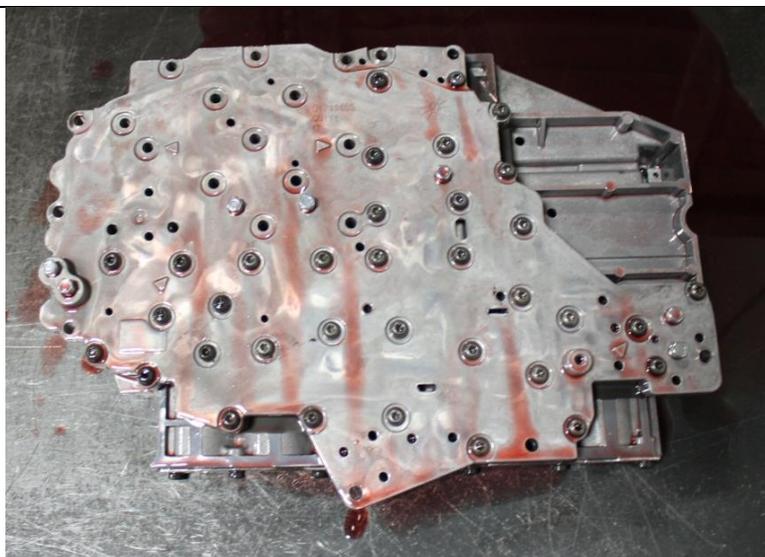
12. Place the valve body on a clean work surface.

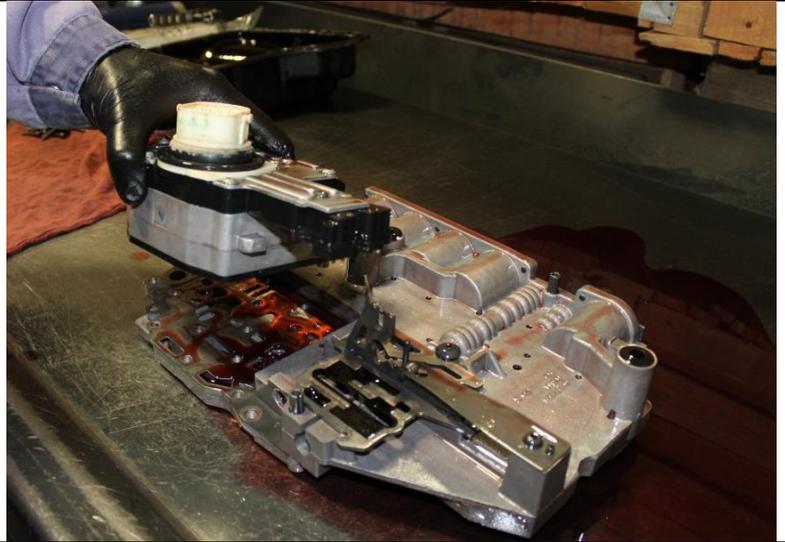
13. Remove fifteen T25 Torx screws securing the solenoid pack to the valve body, remove solenoid pack and place it to the side.

Note: All bolts are the same length.

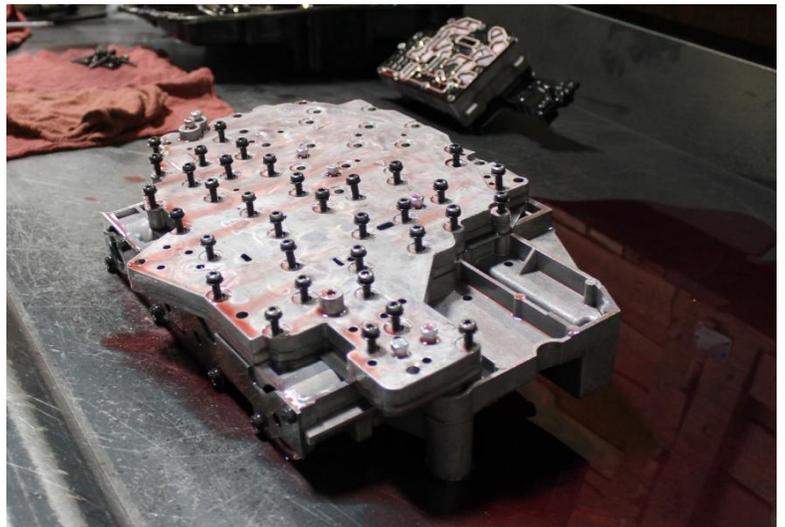
14. Remove remaining thirty five T25 Torx screws securing the valve body halves.

Note: All bolts are the same length.

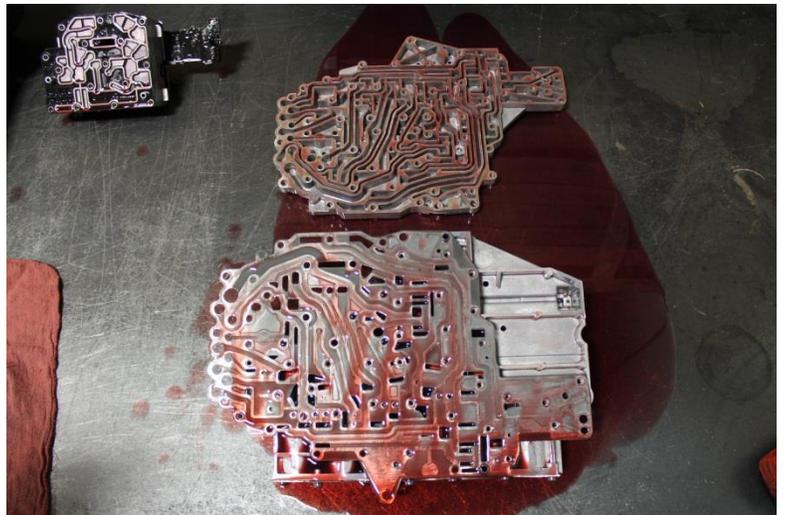
15. Carefully separate the two halves of the valve body. Separate as shown in pictures – *do not invert the larger (top) portion as it contains plastic check balls*. The two halves will have to be wiggled apart as the alignment dowels will be holding them together.

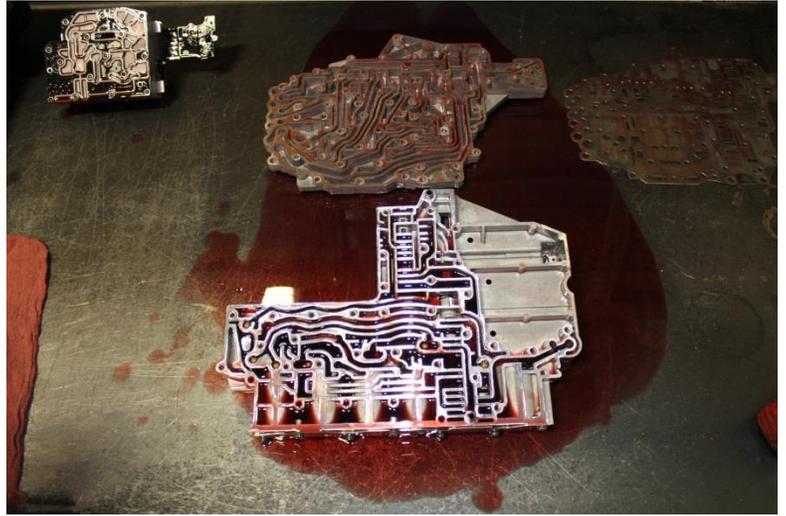
16. Remove old separator plate.

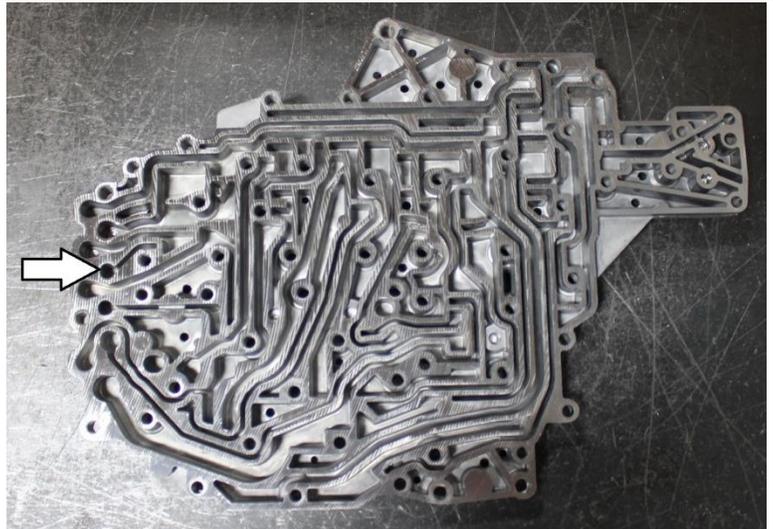
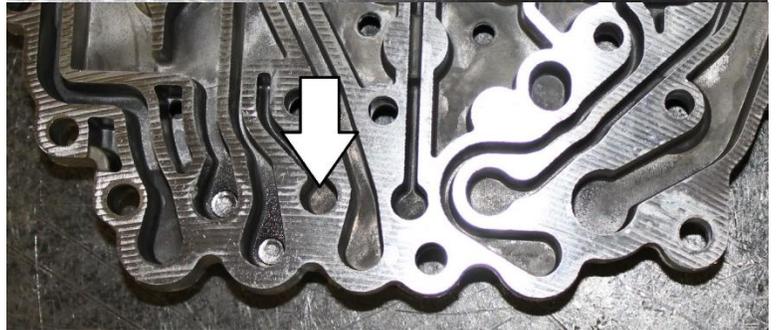
17. Thoroughly clean the bottom (smaller) half of the valve body. Locate the passage to be drilled.

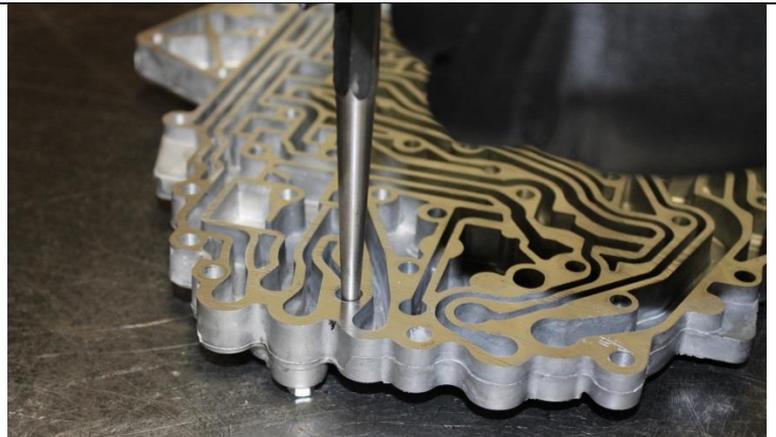
18. Punch center of hole using a center punch.

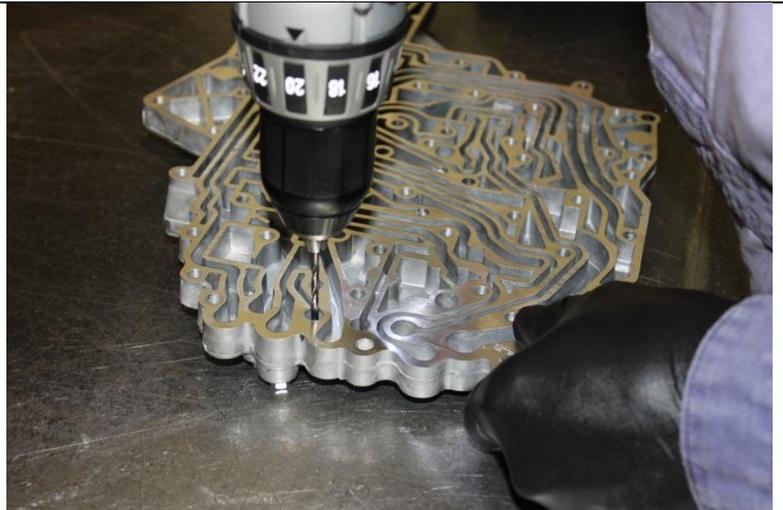
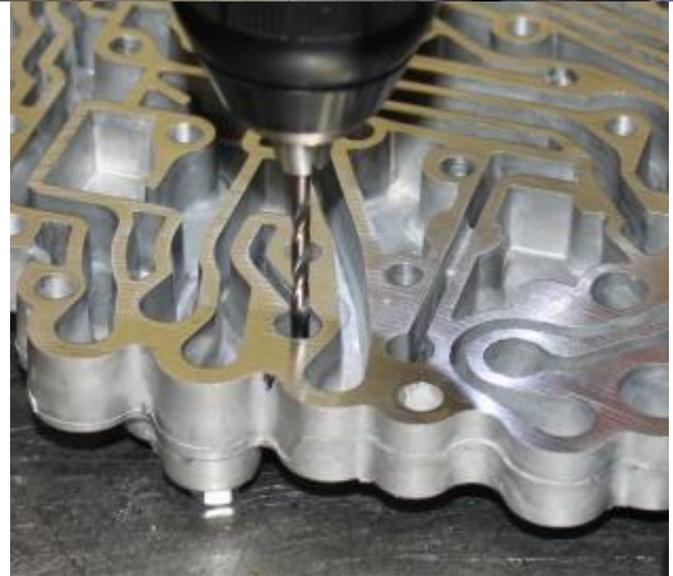
19. Drill hole with 1/8" drill bit.

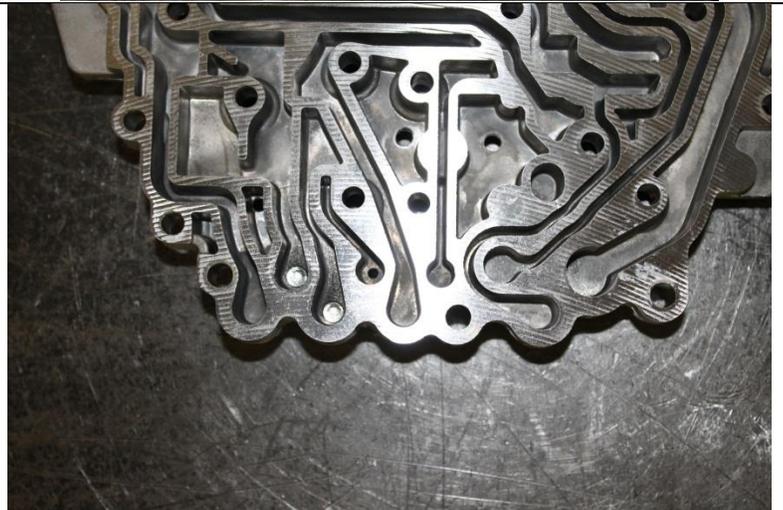
20. Thoroughly remove any burrs and clean all shavings from the valve body. It is imperative that no contaminants are left as they may cause transmission damage.

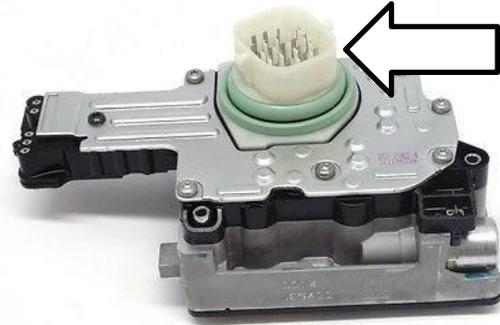
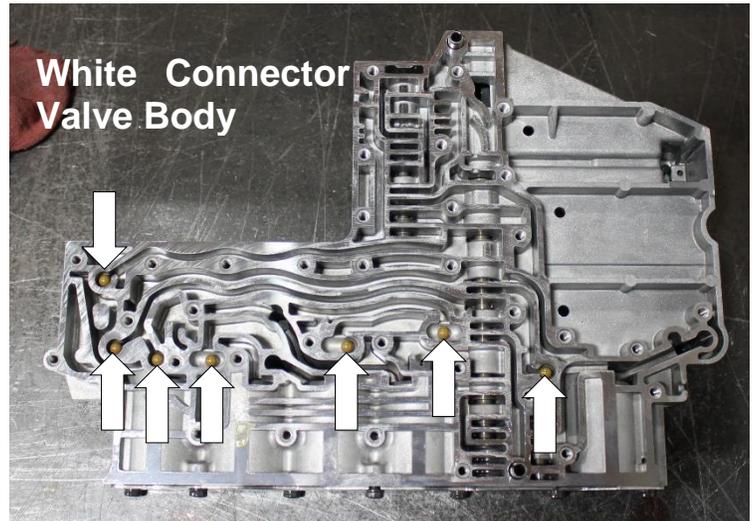
21. **IMPORTANT!** Ensure that all the check balls are in the locations shown.

If the electrical connector on the valve body is white make sure you have all seven check balls installed.

**Discard any extra check balls.**

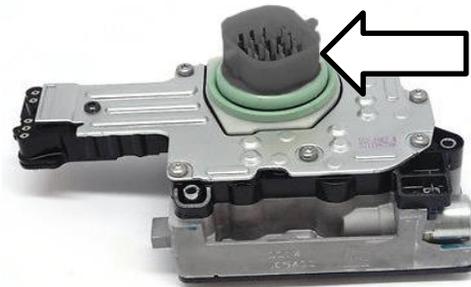
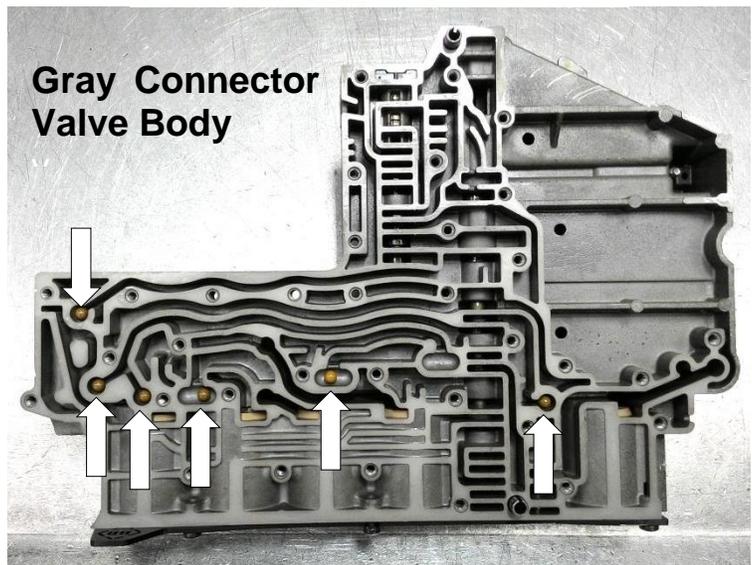
22. **IMPORTANT!** Ensure that all the check balls are in the locations shown.

If the electrical connector on the valve body is gray you will install six check balls rather than the five that were originally installed.

**Use the supplied extra check ball included in this kit for this. Refer to the diagram on the right.**

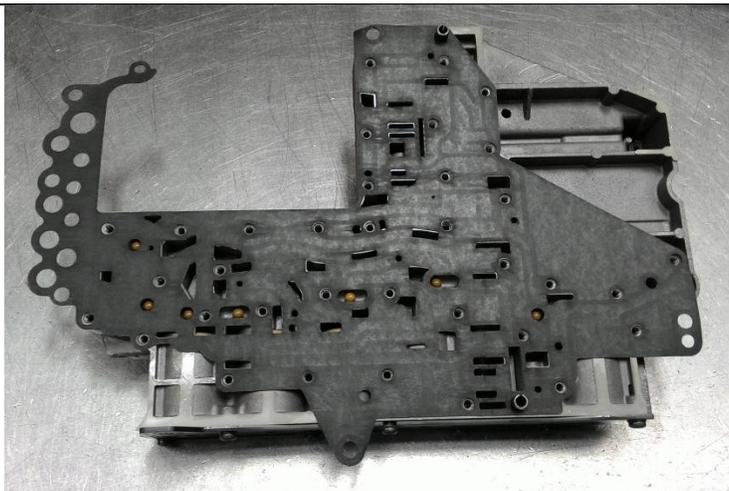
23. Install BD valve body gasket part number 1600186-1 on to the valve body, lining it up with the dowels.

Be careful not to tear or damage the gasket.

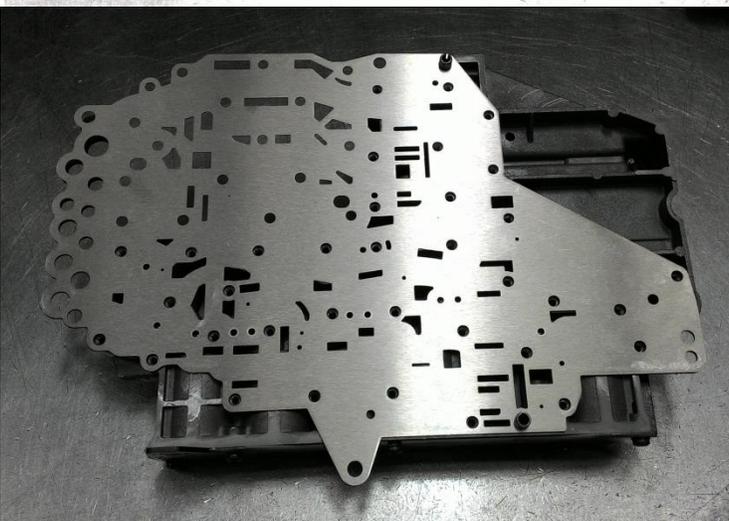
24. Install BD separator plate. Ensure it fits flat on the valve body.

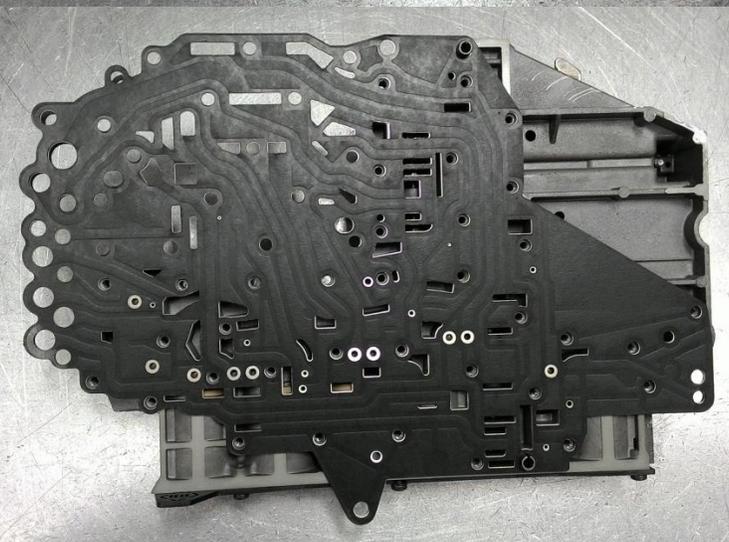
25. Install the second BD valve body gasket part number 1600186-2 on the separator plate, lining it up with the dowels.

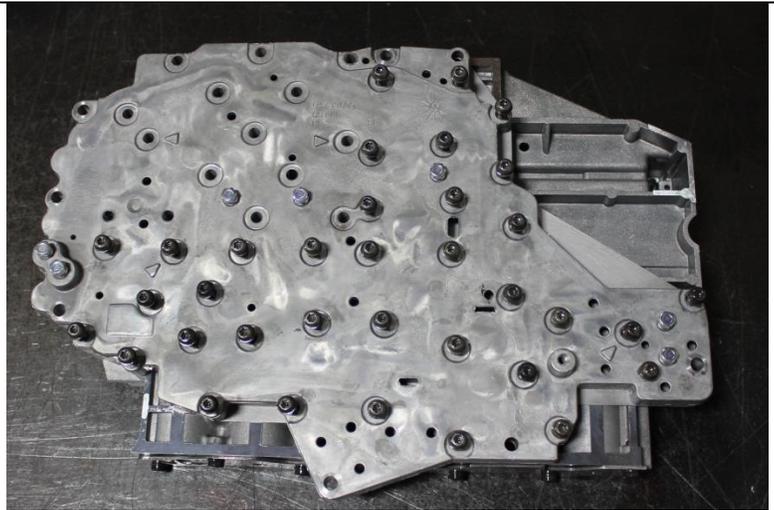
26. Re-install bottom (smaller) half of valve body. Ensure it fits flat on the separator plate/gasket. It may need to be worked downwards while rocking to be installed over the dowels. Install attaching screws so they are fully seated but do not tighten until the solenoid pack has been installed.

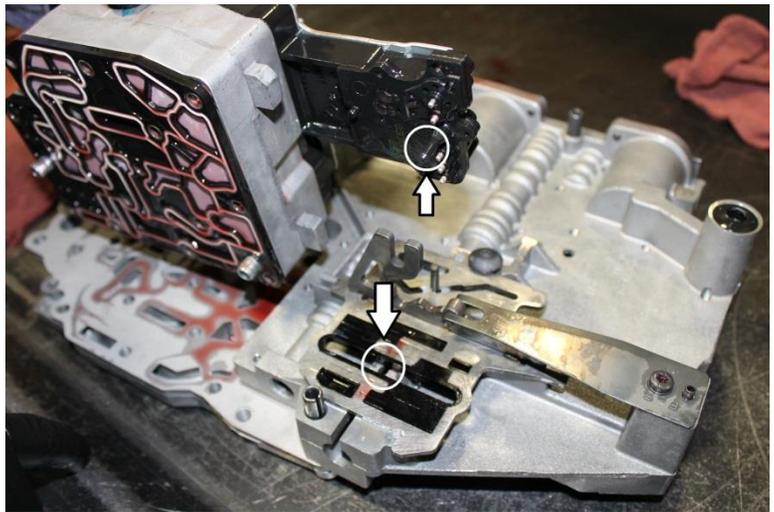
27. Re-install solenoid pack onto valve body. Be sure to properly align the pin on the solenoid pack with the slot on the valve body. Due to the alignment dowels, the valve body may need to be wiggled down into position. Install solenoid pack attaching screws. Install remaining Torx screws to fasten the solenoid pack to the valve body.

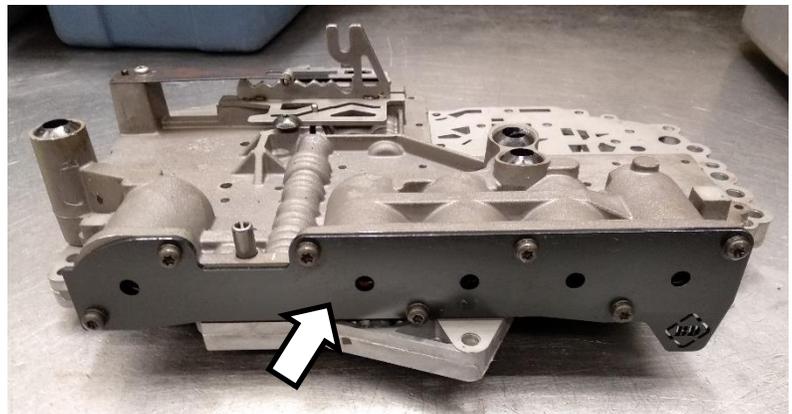
28. Torque all valve body Torx screws to 55 in-lbs, working from the center outwards. Carefully check that no screws were missed.

29. Remove the accumulator retainer plate and reinstall the supplied BD accumulator plate. Torque screws to 60 in-lb.

**IMPORTANT:** Over or under-torquing these fasteners can lead to blown out accumulator plates.

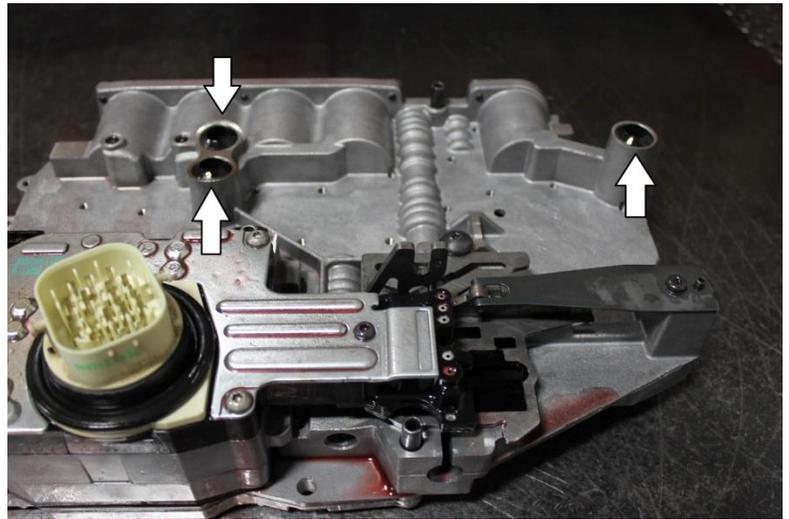
30. Inspect the three rubber seals on the top of the valve body, replace with supplied seals if they are nicked or otherwise damaged. Ensure the seal mating surface on the transmission is clean.

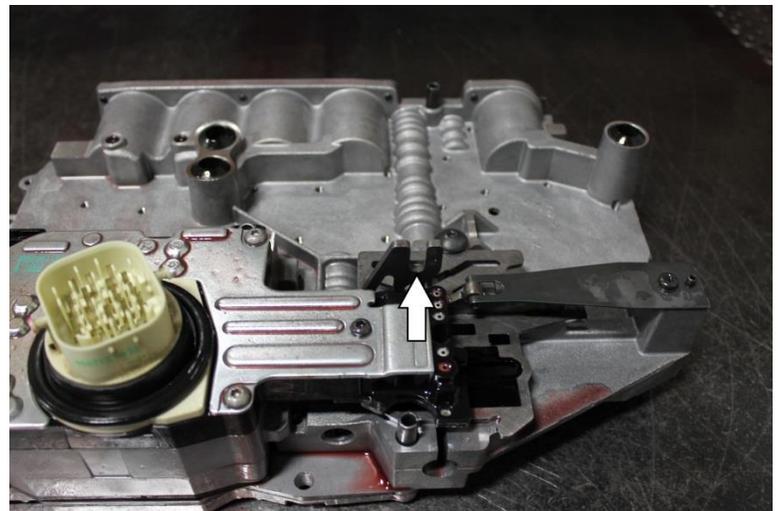
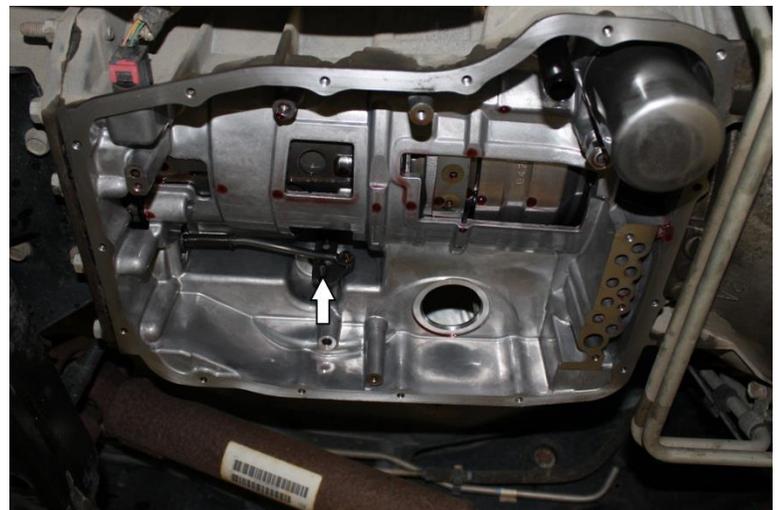
32. Check that the shift lever on the valve body lines up with the shift lever on the transmission and lift the valve body back into the transmission. Start the 8mm screws by hand, do not tighten yet. Work the shift lever on the outside of the transmission case by hand to ensure that the lever is making contact with the valve body correctly.

**IMPORTANT:** Use great care when reinstalling the valve body, the gasket that mates with the front of the case must line up correctly. Do not fold or pinch during installation.

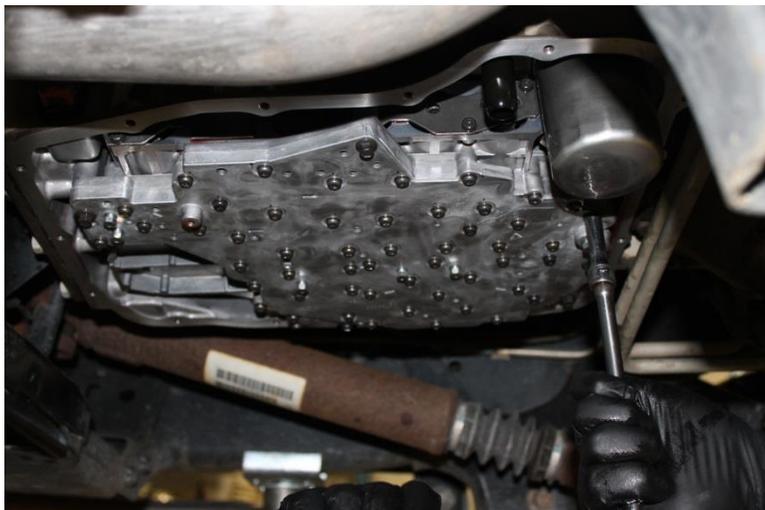
33. Torque the valve body attaching bolts to 105 in/lbs.

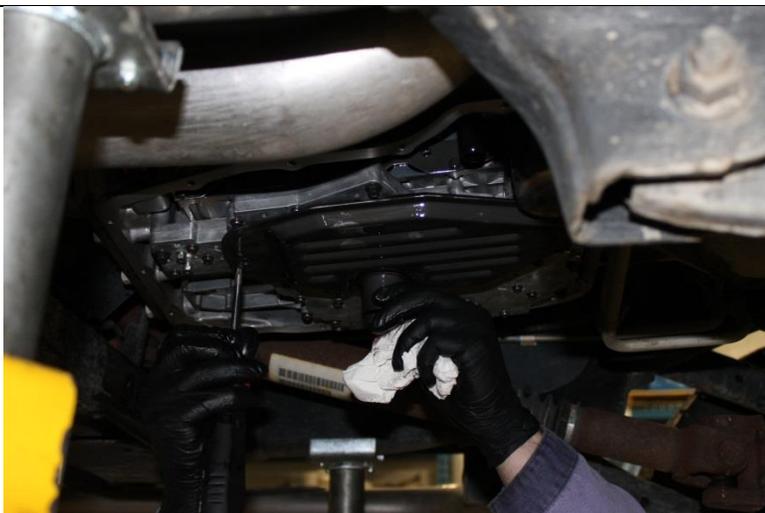
34. If desired, install new filter(s). Otherwise, reinstall the filter/pickup assembly. Torque to 50 in/lbs.

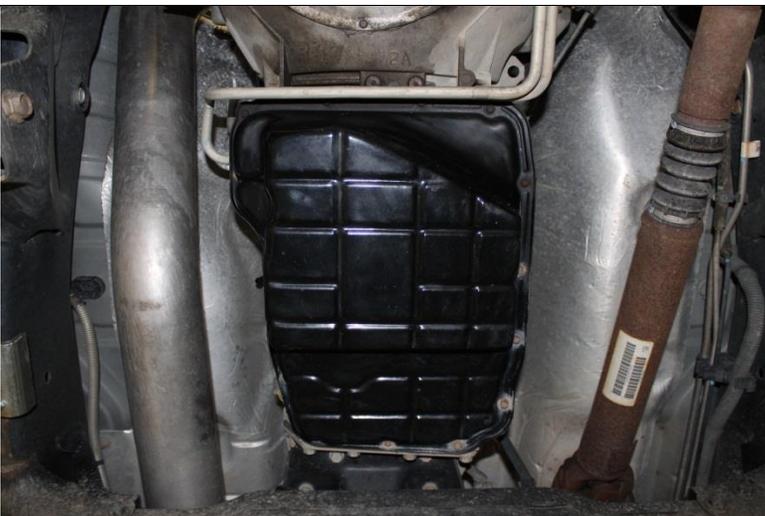
35. Place the supplied gasket on the transmission pan. Hold pan below transmission and install attaching screws. Torque the pan screws to 105 in/lbs.

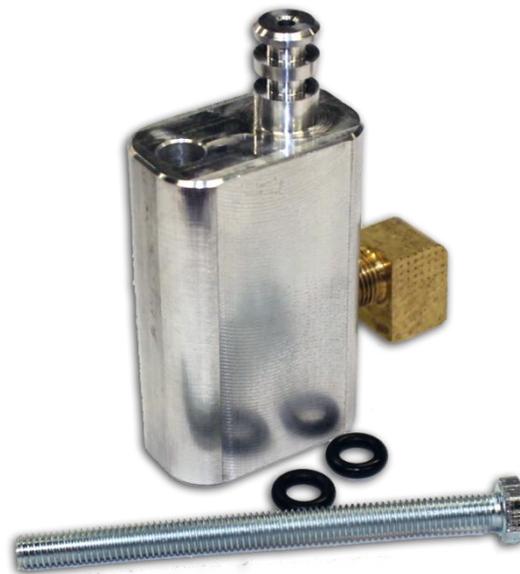
ADAPTER KIT BD# 1061529

42. Note. If you would like to verify the increases in line pressure, use adapter kit (BD 1061529) in conjunction with a 300psi gauge. Pressures at wide open throttle should be between 240 – 260 PSI with a mechanical gauge.

Use this kit with a 300 psi gauge.
